CONFIDENTIAL INFORMATION REPORT

20 July 1959

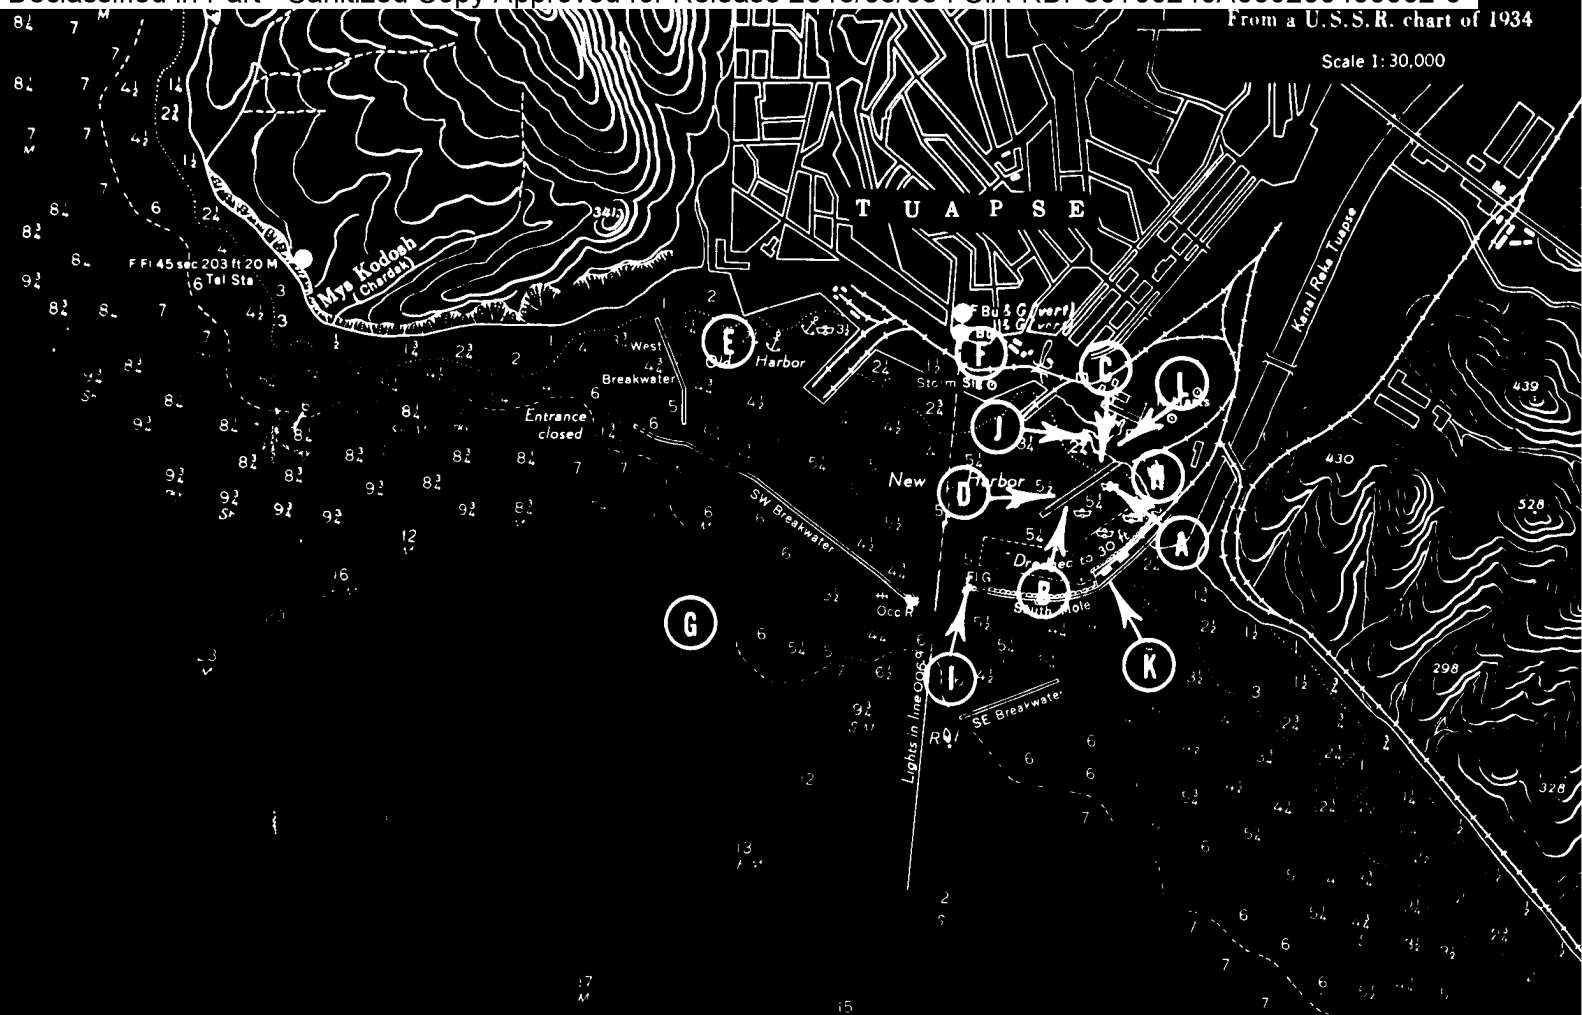
From a U.S.S.R. chart of 1934

Exit onto concrete platform,
5 steps down to ground
level.

Fence with gate; gate
normally closed

Check point, room 6x12',
building has 2 floors

Pump exposed here, size unknown.

Water fittings. Hose has
to be led out across pier.

Most of fittings is within a
raised concrete "island". Walk-
way over this is approached by
concrete steps at either end.
Walkway to steel plate.

Long, continuous iron plate, flush
with pier level. [redacted]
petroleum lines run underneath this
because at frequent intervals a
portion of the plates would be
lifted by a worm checking some-
thing underneath. Extent of plating
unknown toward end of pier.

Pier length 1000'
